Customer Bulletin

Bulletin No: 22-0912
Date: September 12, 2022
Revised 9/21/22
Attn: TDT1000 Owners
Subject: Database Issue
Effective: Immediately

TDT1000/SensorCheck Advisory: Erroneous Results Being Reported

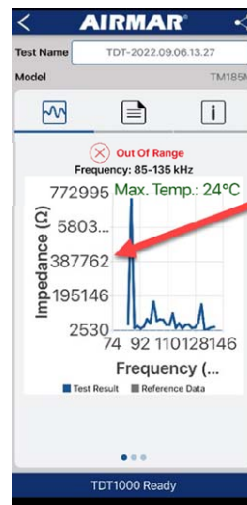
Three weeks ago, Airmar began receiving reports from the field of pre-install transducer test results showing Out of Range, when the transducer is actually operating correctly. These test results are displaying extremely high impedance (see inset photo) and delivering an Out of Range test result on the SensorCheck app. This can happen even when the transducer is within range and operating as designed. We have seen this occur more frequently with medium frequency Chirp transducers, but we cannot rule out other models and frequencies at this time.

Note extremely high
Impedance

On September 14th Airmar released new, corrected data to the SensorCheck database which fixes this issue. Our team was able to determine that the issue was limited to a few models. After correcting the data, they tested extensively and determined the issue to be corrected. The next time your version of SensorCheck connects to the internet, it will automatically download the updated, corrected data. If you have concerns about test results, we always encourage you to call our Technical Support team at 1-800-543-6326 in the U.S. or +33 (0) 2 23 52 06 48 in Europe.

Should you see test results similar to what we have described, our recommendation at this time is to share those test results with our Tech Support team (Certified@Airmar.com) and follow up with a phone call (1-833-ACI-TECH). In line with our Warranty and Onboard Support policy, DO NOT return or remove a suspected transducer prior to discussing the test results with an Airmar Tech Support member and receiving an RMA number.
